**CLEAN WATER ACT COMPLIANCE INSPECTION
U.S. ENVIRONMENTAL PROTECTION AGENCY, REGION 5**

Legend Farms Dairy, LLC

Date of Inspection: April 20, 2017 - April 21, 2017

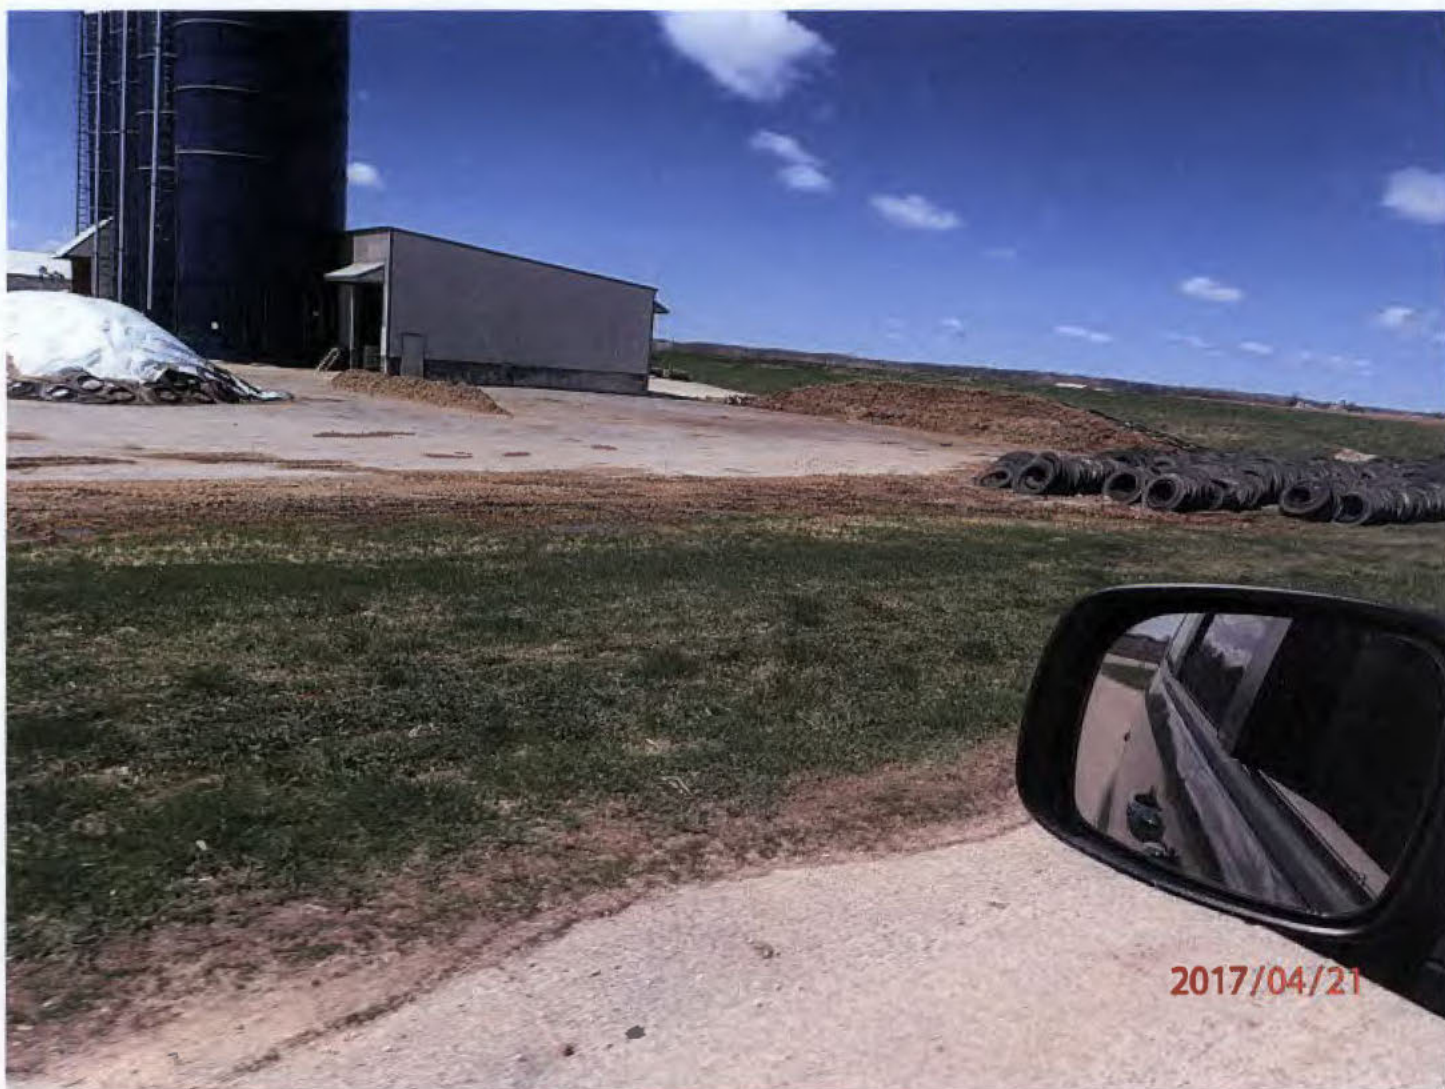
Photo: P4210106

Description: EPA did not observe any other sources, except Legend Farms Dairy, LLC discharging feed and surface water into the roadside ditch on west side of Lilac Lane due to the slope of the silage pad and slope of the roadside ditch to the south.

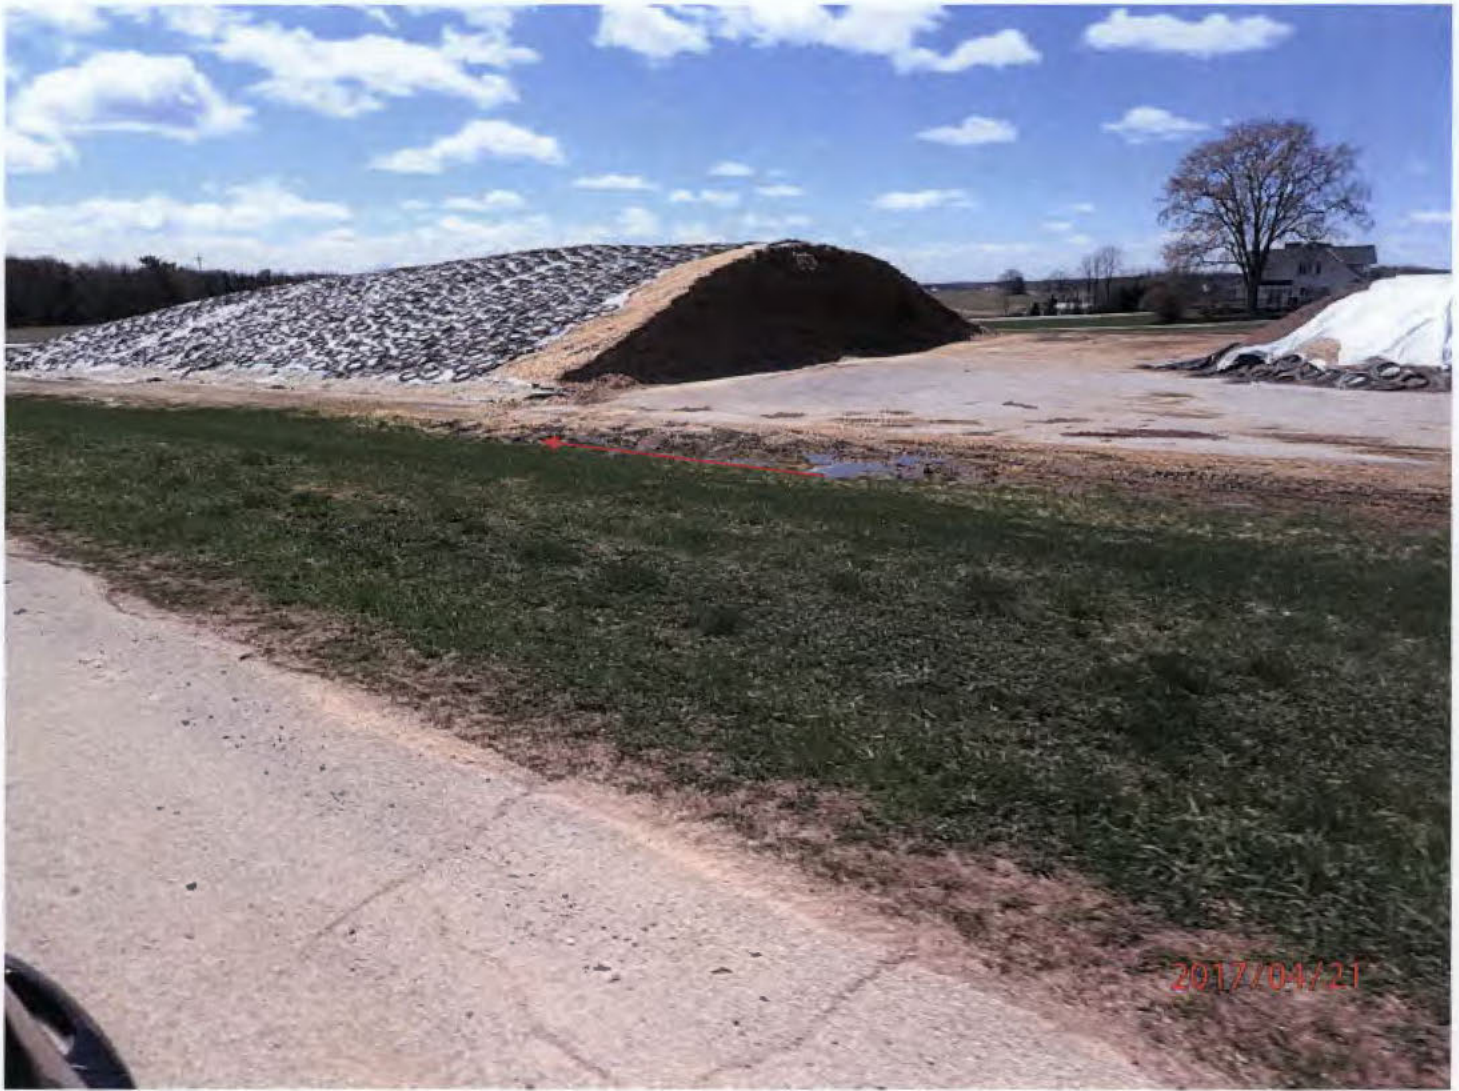
Photo: P4210107

Description: EPA observed feed and surface water (process wastewater) discharging off of the silage pad to the east and flowing south toward County Road F. EPA verified that there were no other sources of process wastewater north of the silage pad discharging into the roadside ditch west of Lilac Lane.

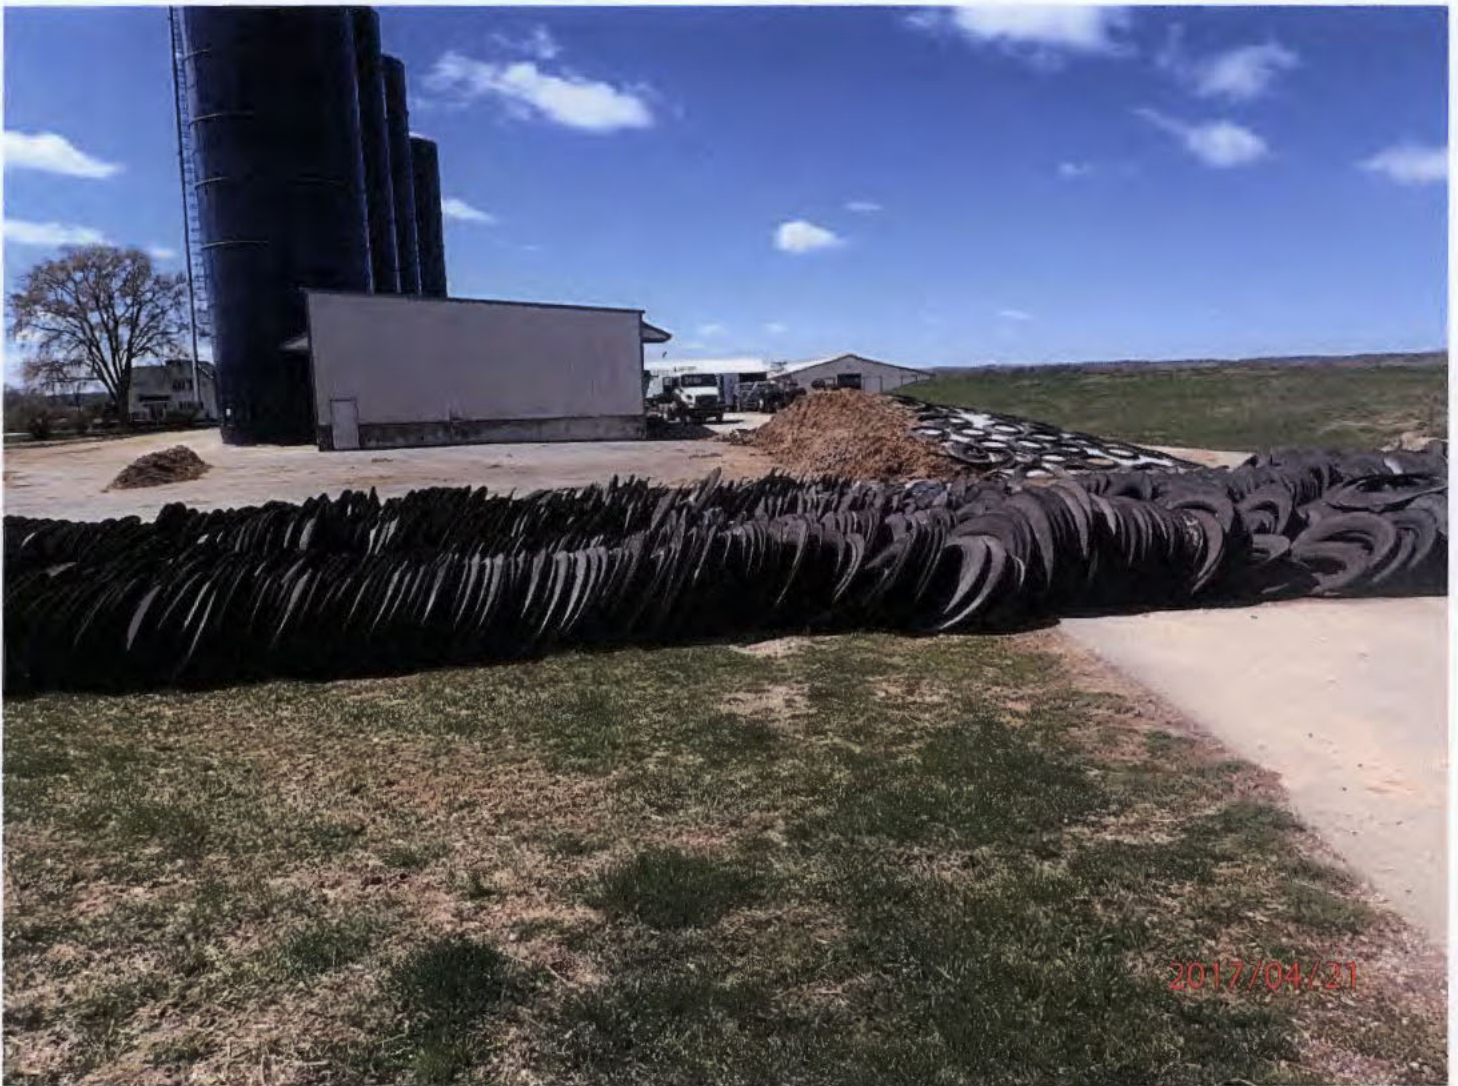
Photo: P4210108

Description: EPA did not observe any other sources, except Legend Farms Dairy, LLC discharging feed and surface water into the roadside ditch on west side of Lilac Lane due to the slope of the silage pad and slope of the roadside ditch to the south.

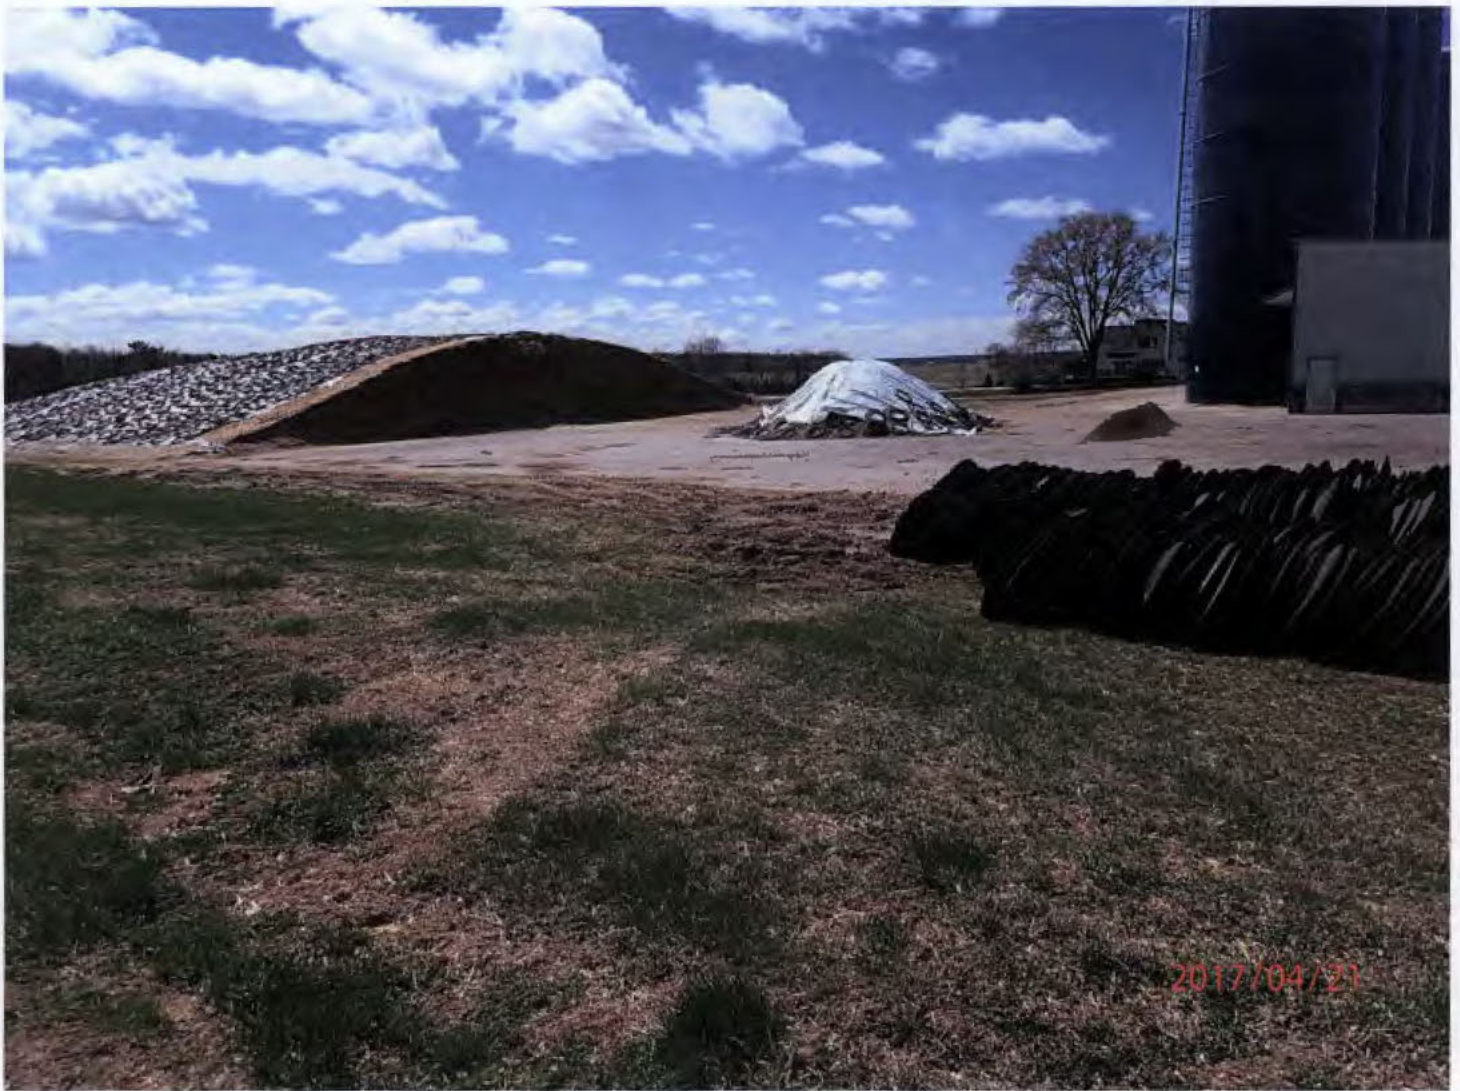
Photo: P4210109

Description: EPA observed feed and surface water (process wastewater) discharging off of the silage pad discharges off the pad to the east into the roadside ditch west of Lilac Lane and flows south toward County Road F.

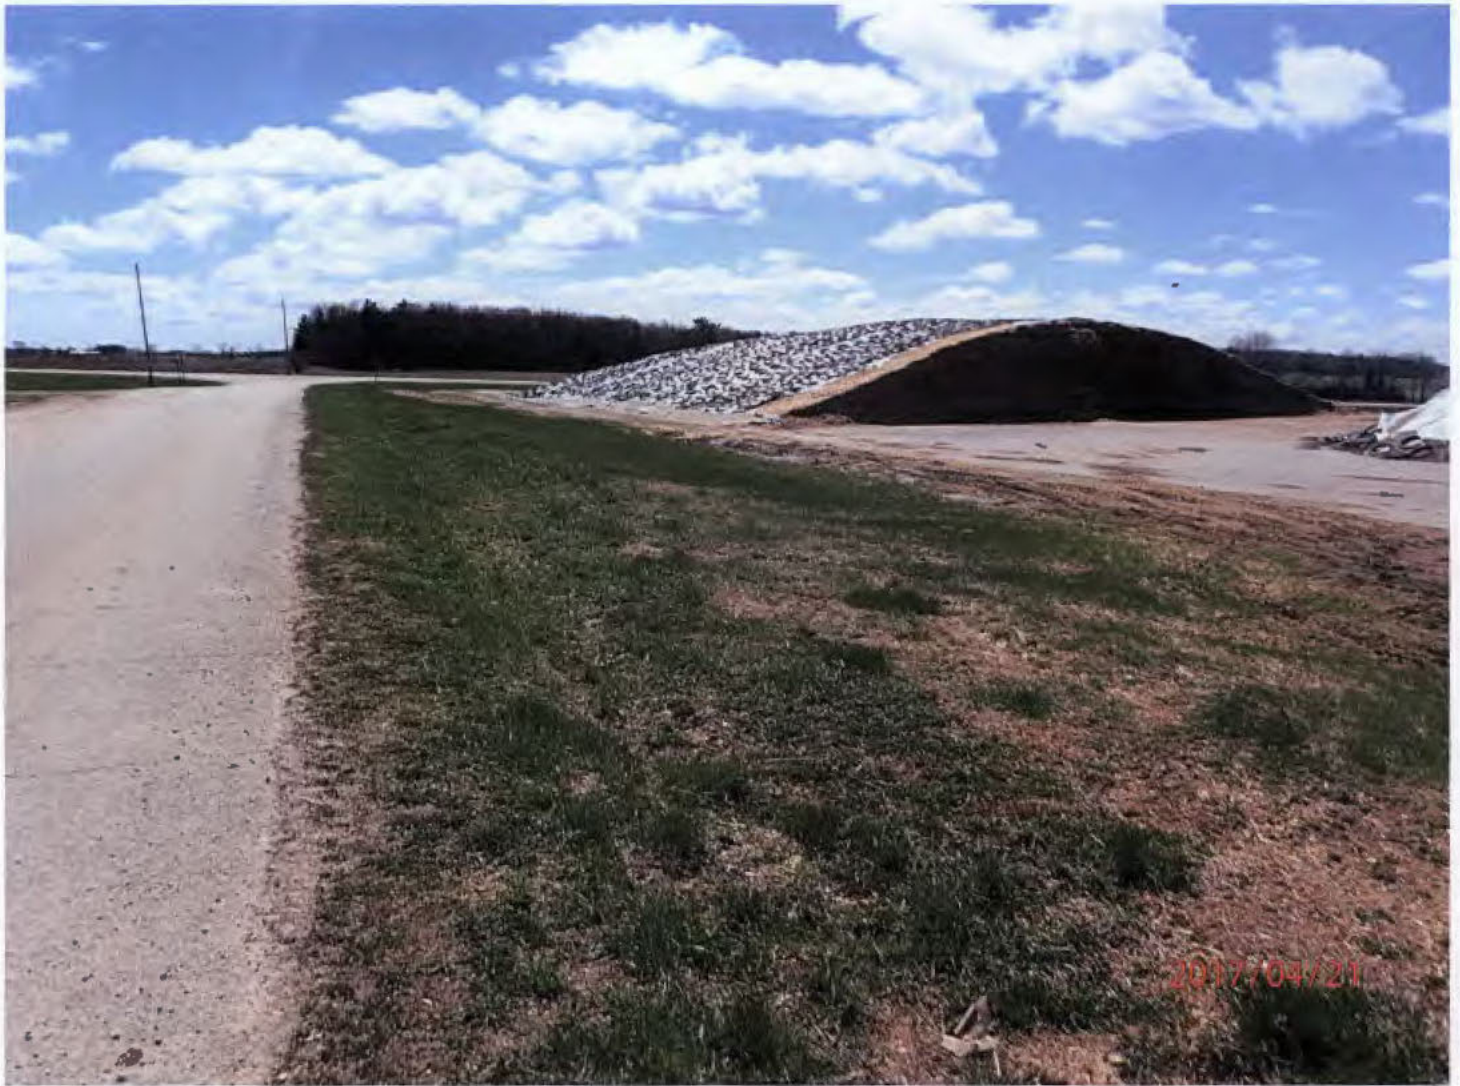
Photo: P4210110

Description: EPA observed that the feed and surface water (process wastewater) off of the silage pad discharges off the pad to the east into the roadside ditch west of Lilac Lane and flows south toward County Road F.

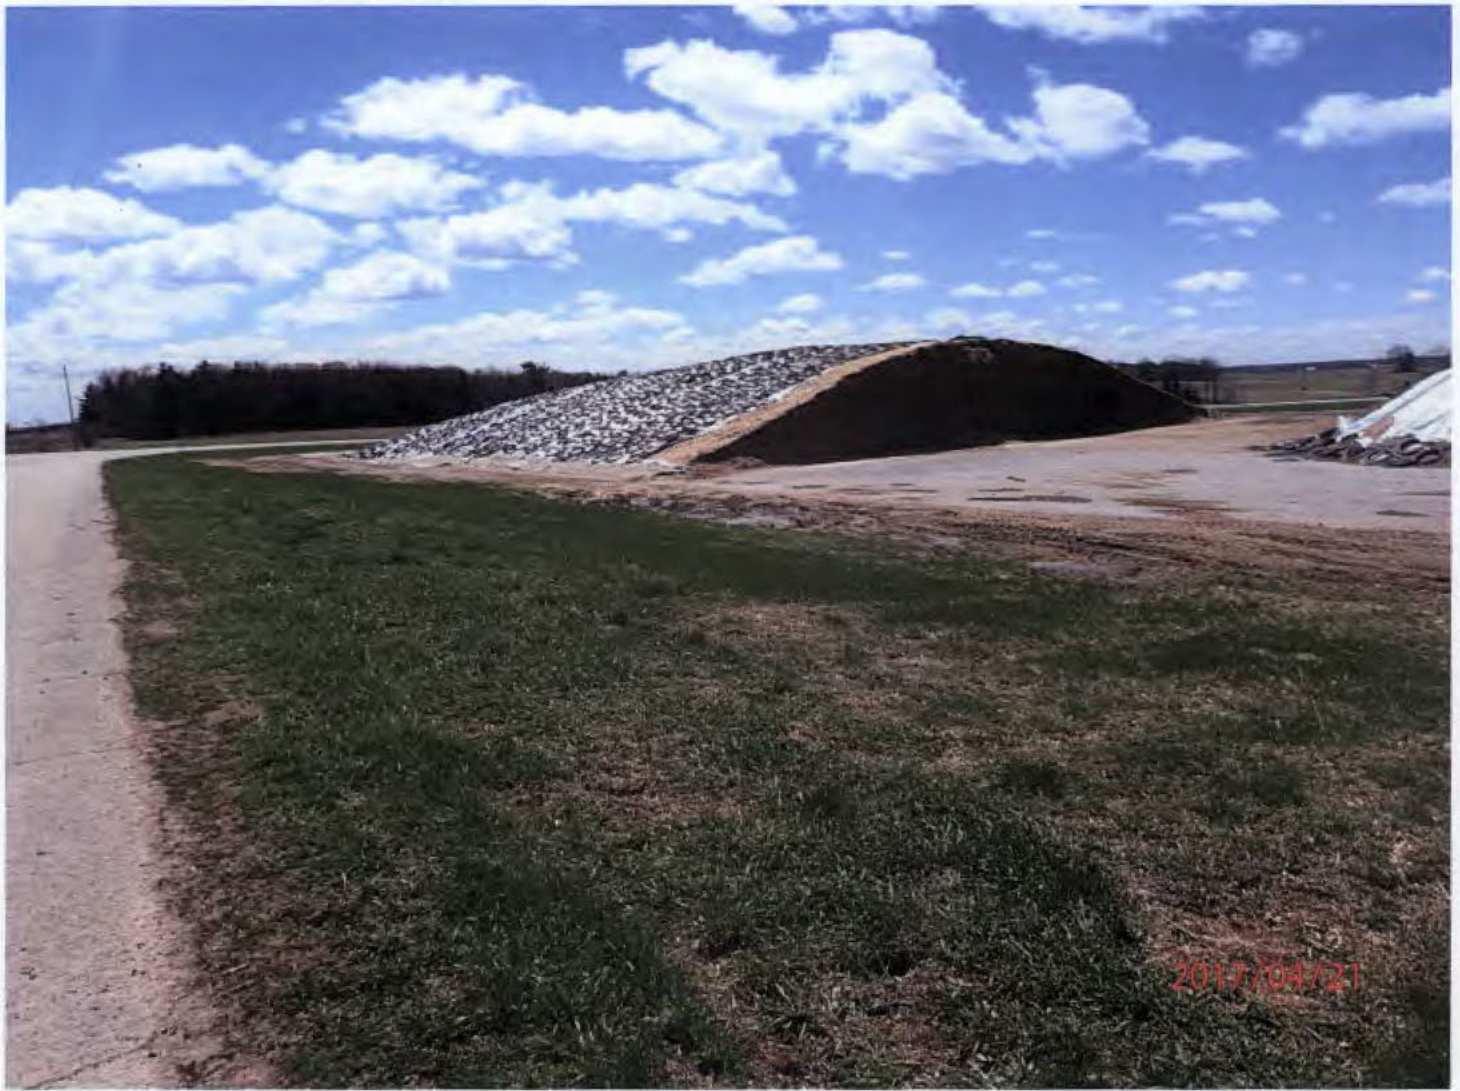
Photo: P421011

Description: EPA observed feed and surface water (process wastewater) off of the silage pad discharges off the pad to the east into the roadside ditch west of Lilac Lane and flows south toward County Road F.

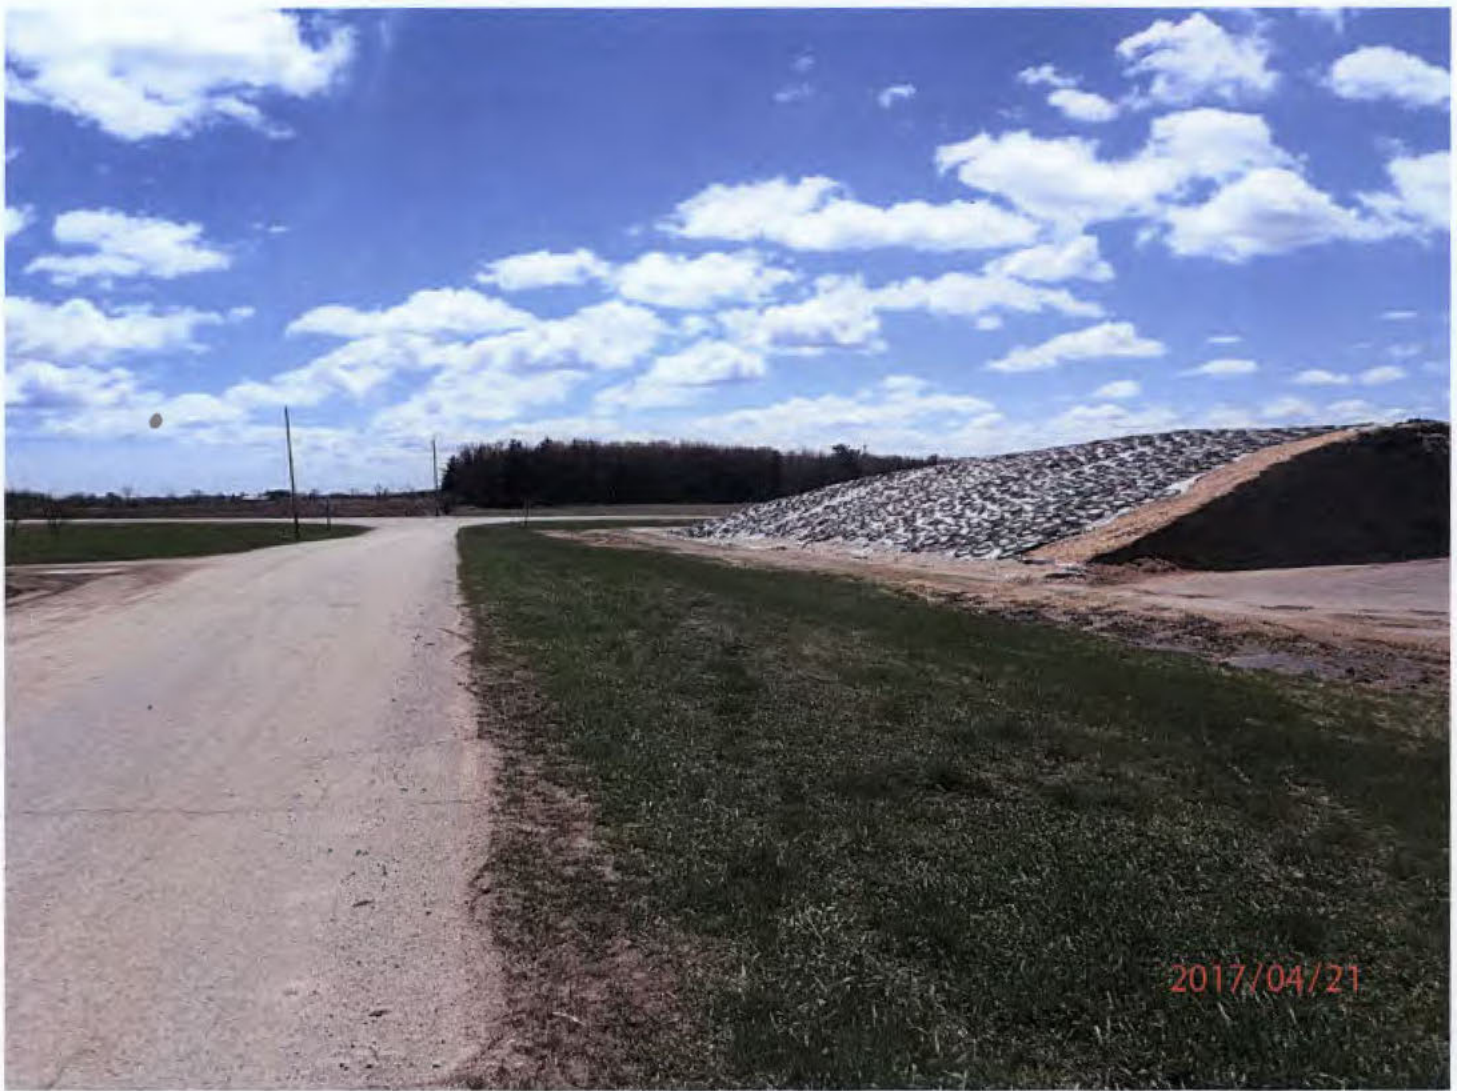
Photo: P4210112

Description: EPA observed feed and surface water (process wastewater) off of the silage pad discharges off the pad to the east into the roadside ditch west of Lilac Lane and flows south toward County Road F.

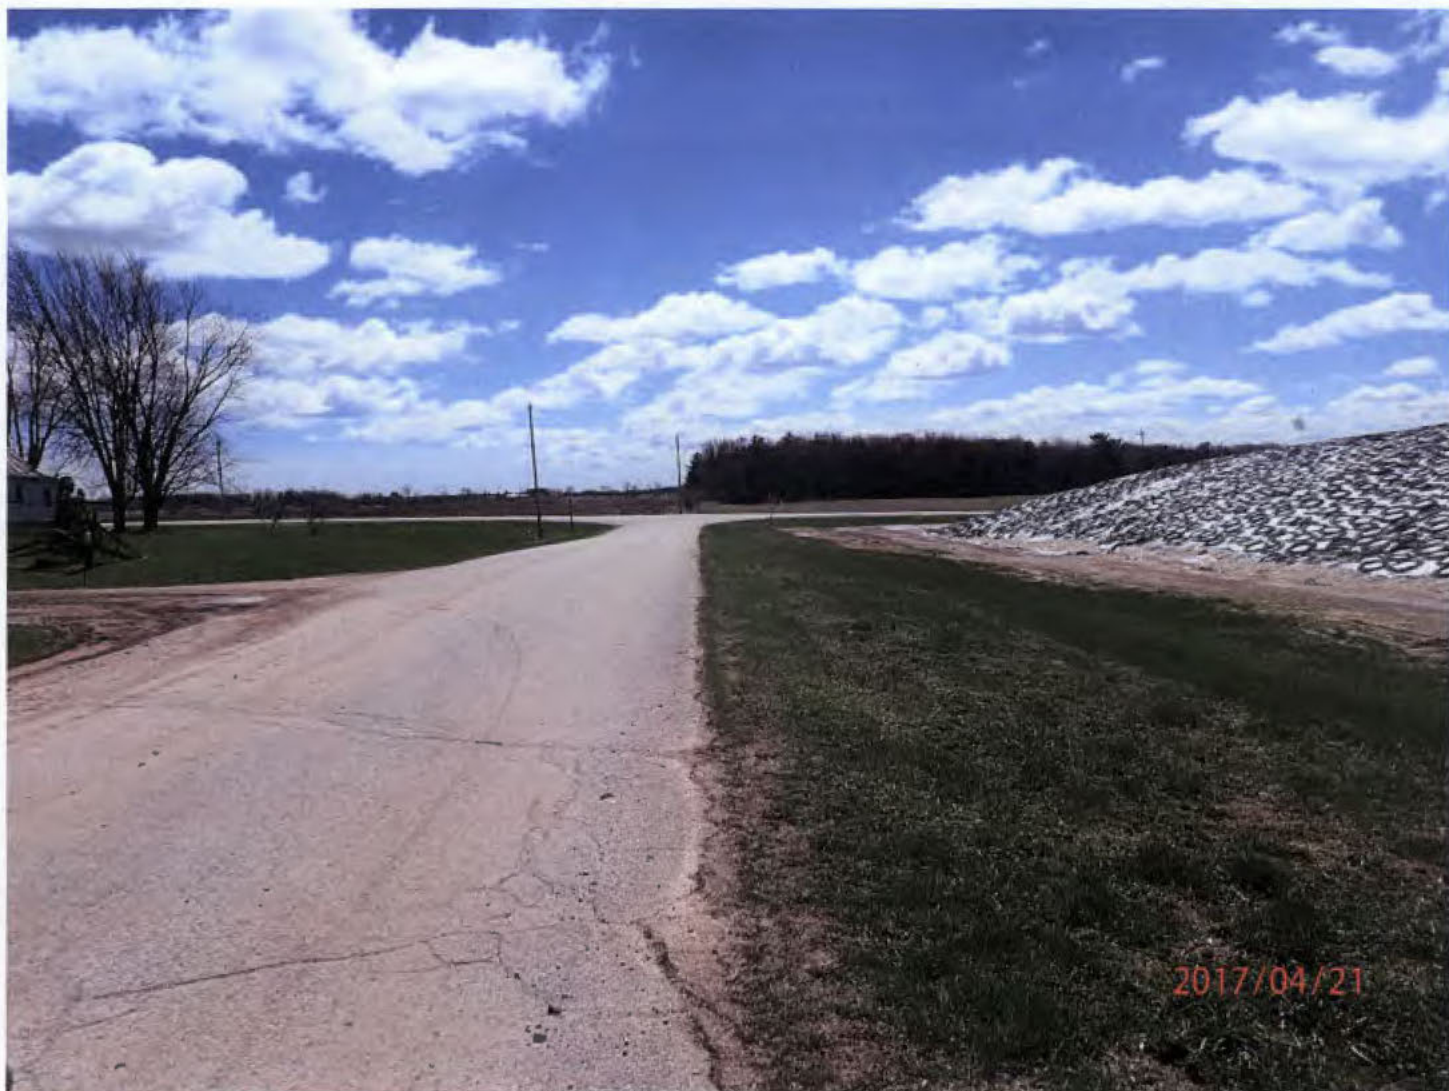
Photo: P4210113

Description: EPA observed feed and surface water (process wastewater) off of the silage pad discharges off the pad to the east into the roadside ditch west of Lilac Lane and flows south toward County Road F.

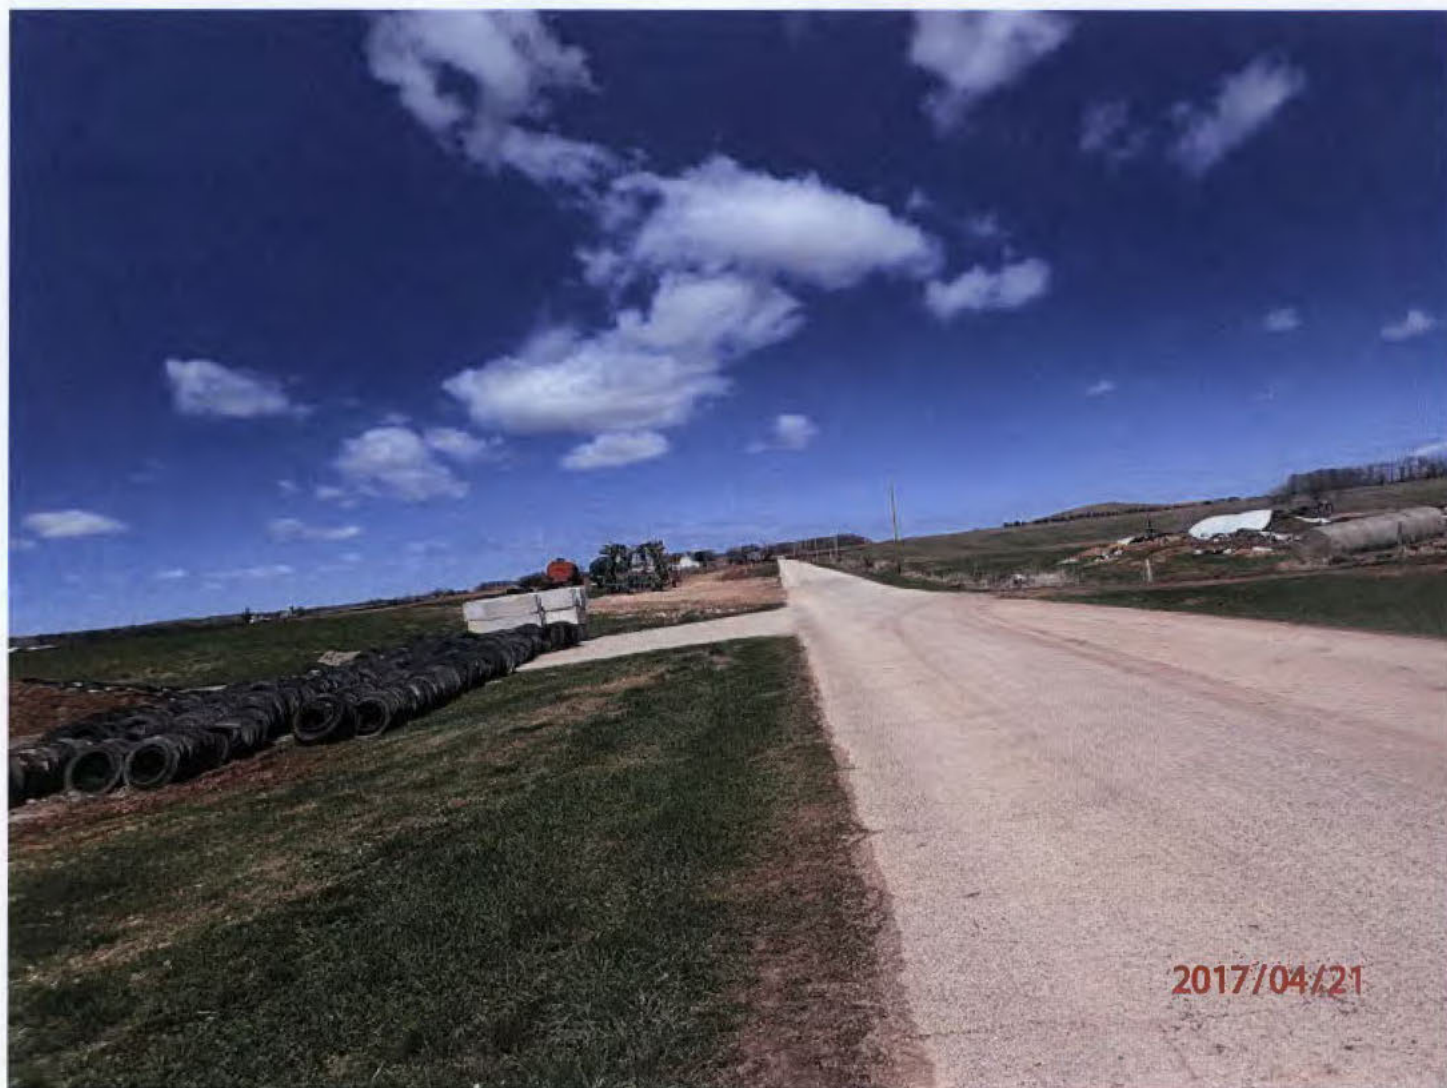
Photo: P4210114

Description: EPA observed that the silage pad, roadside ditch, and Lilac Road are sloped to south no runoff north of the silage pad discharges into the roadside ditch west of Lilac Lane.

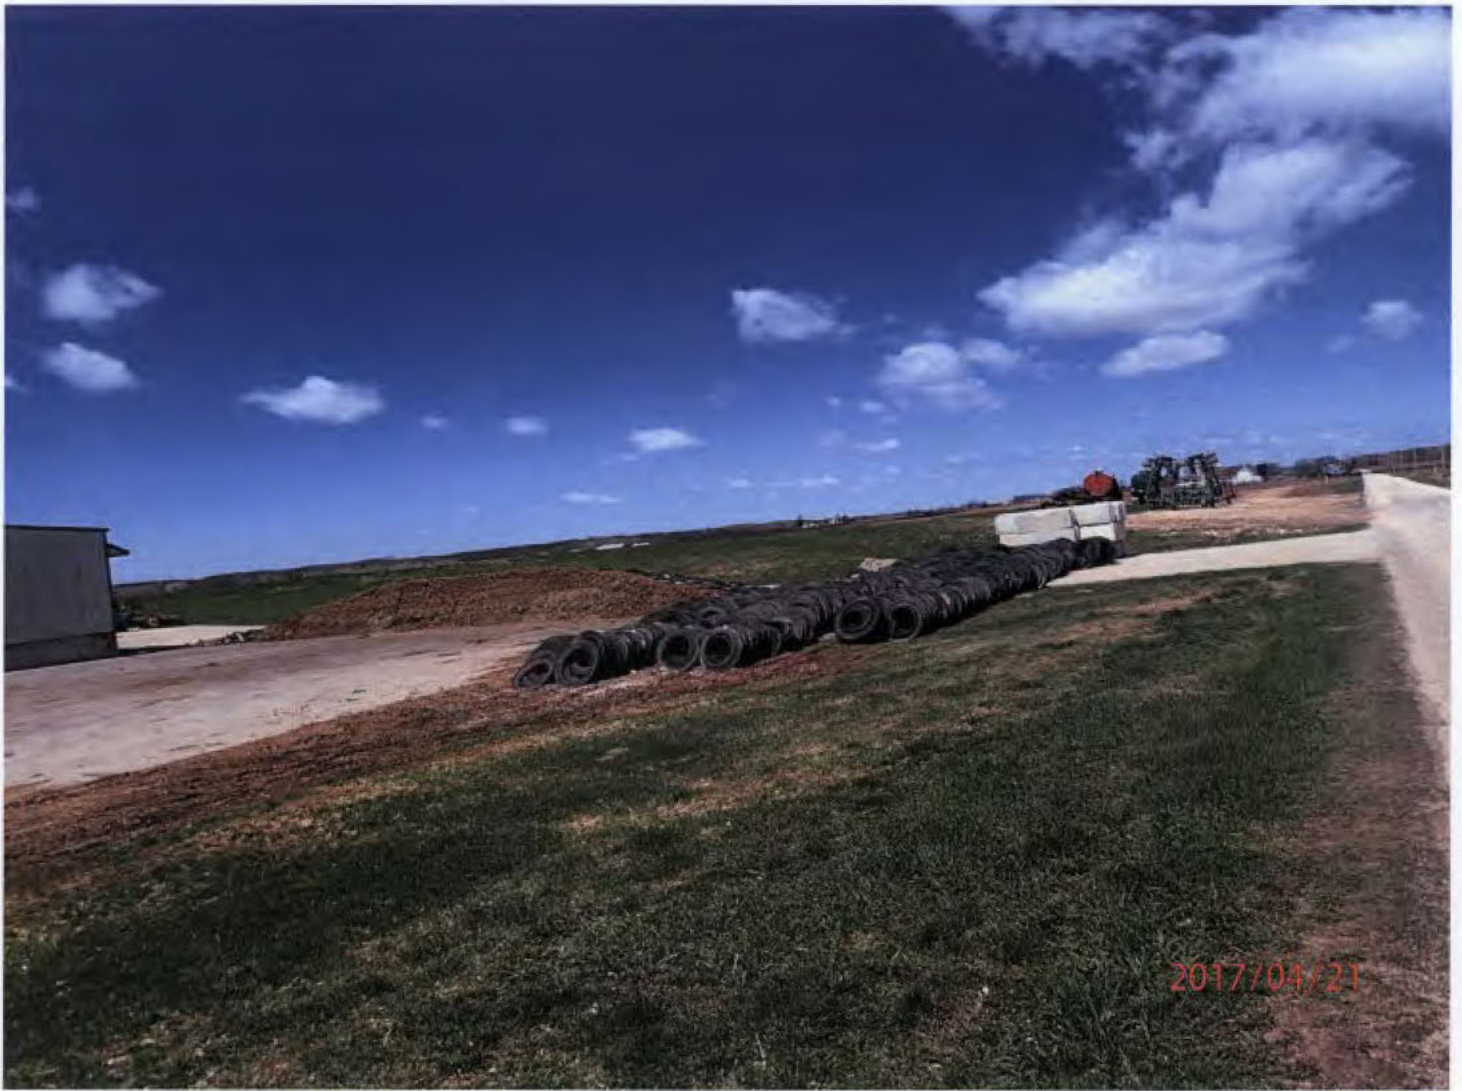
Photo: P4210115

Description: Close-up of the feed off of the silage pad. Documenting that there is a hill behind the silage to the north and tires stacked and no additional runoff is coming down the ditch along the west side of Lilac Lane

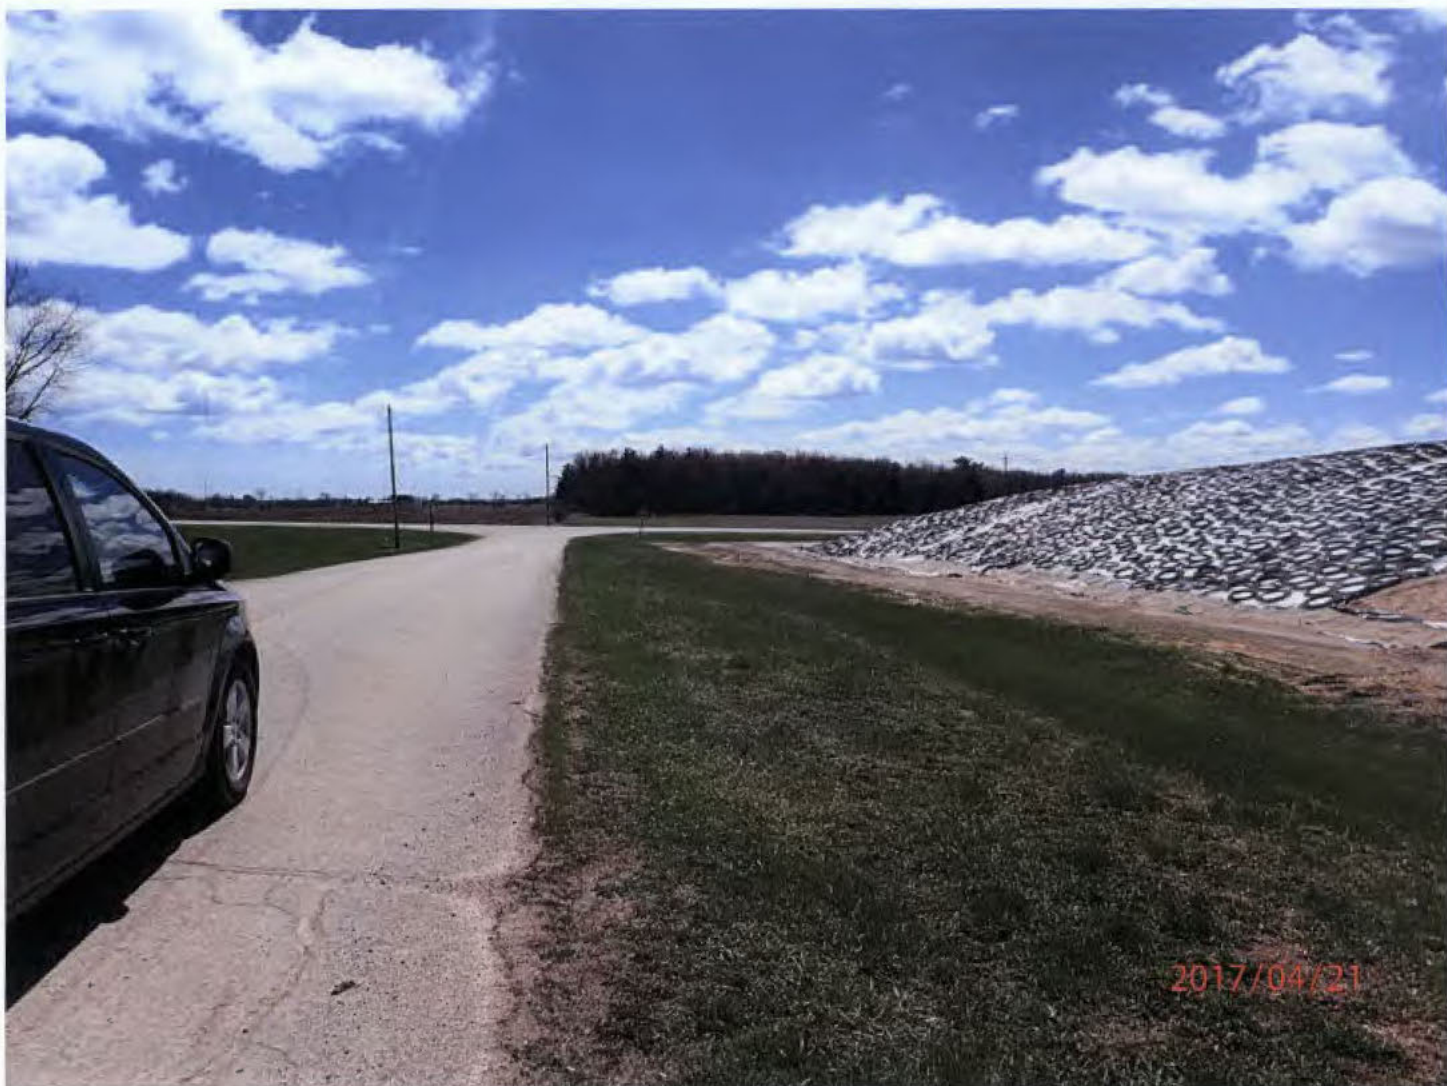
Photo: P4210116

Description: EPA observed feed and surface water (process wastewater) discharging off of the silage pad at this location, but farther to south process wastewater was discharging off of the silage pad. EPA observed that the process wastewater was only coming from the silage pad.

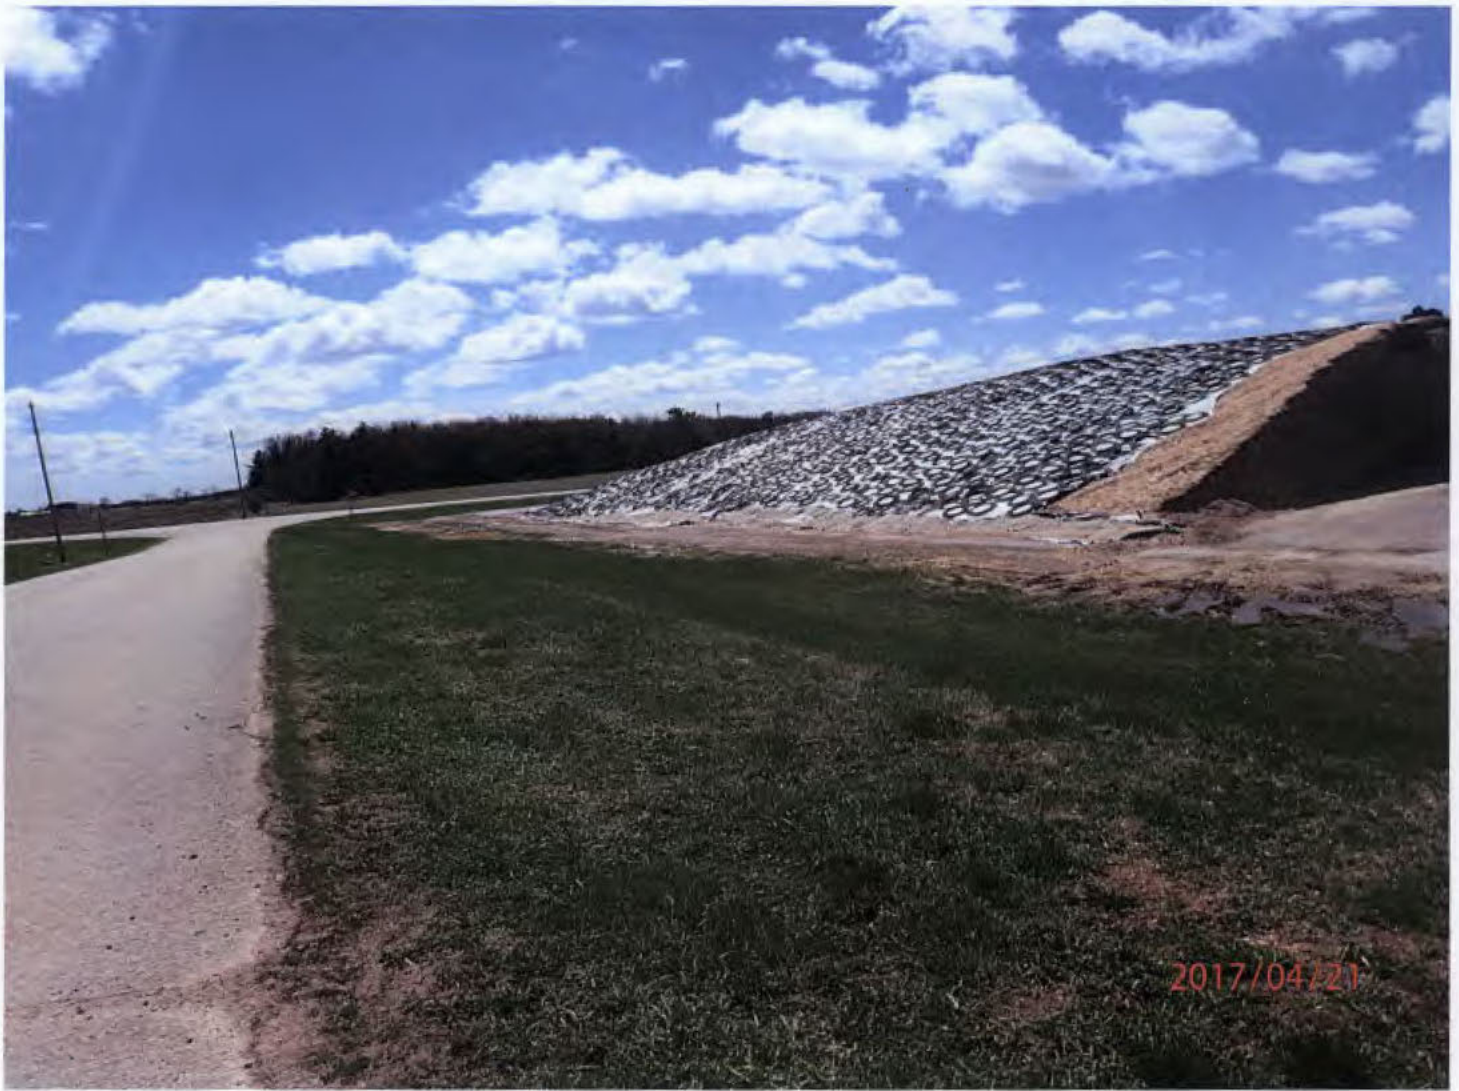
Photo: P4210117

Description: EPA observed feed and surface water (process) wastewater discharging off of the silage pad at this location, but farther to south process wastewater was flowing to the south. EPA observed that the process wastewater was only coming from the silage pad.

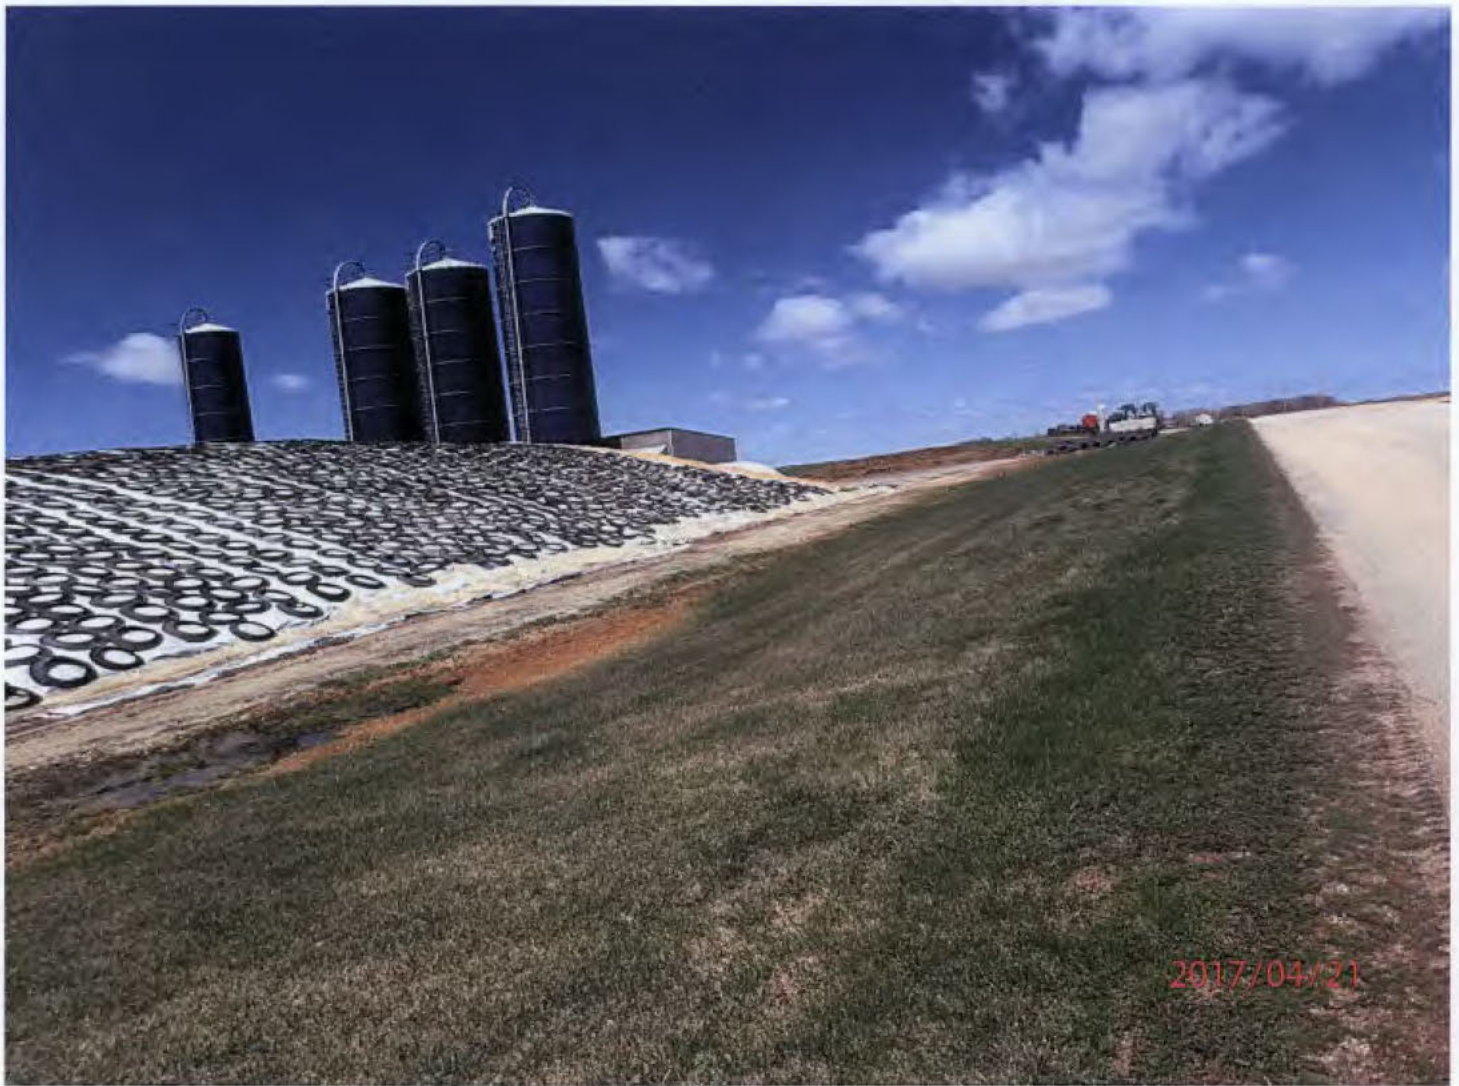
Photo: P4210118

Description: EPA observed feed and surface water (process wastewater) discharging the silage pad at this location. EPA observed that the process wastewater was only coming from the silage pad.

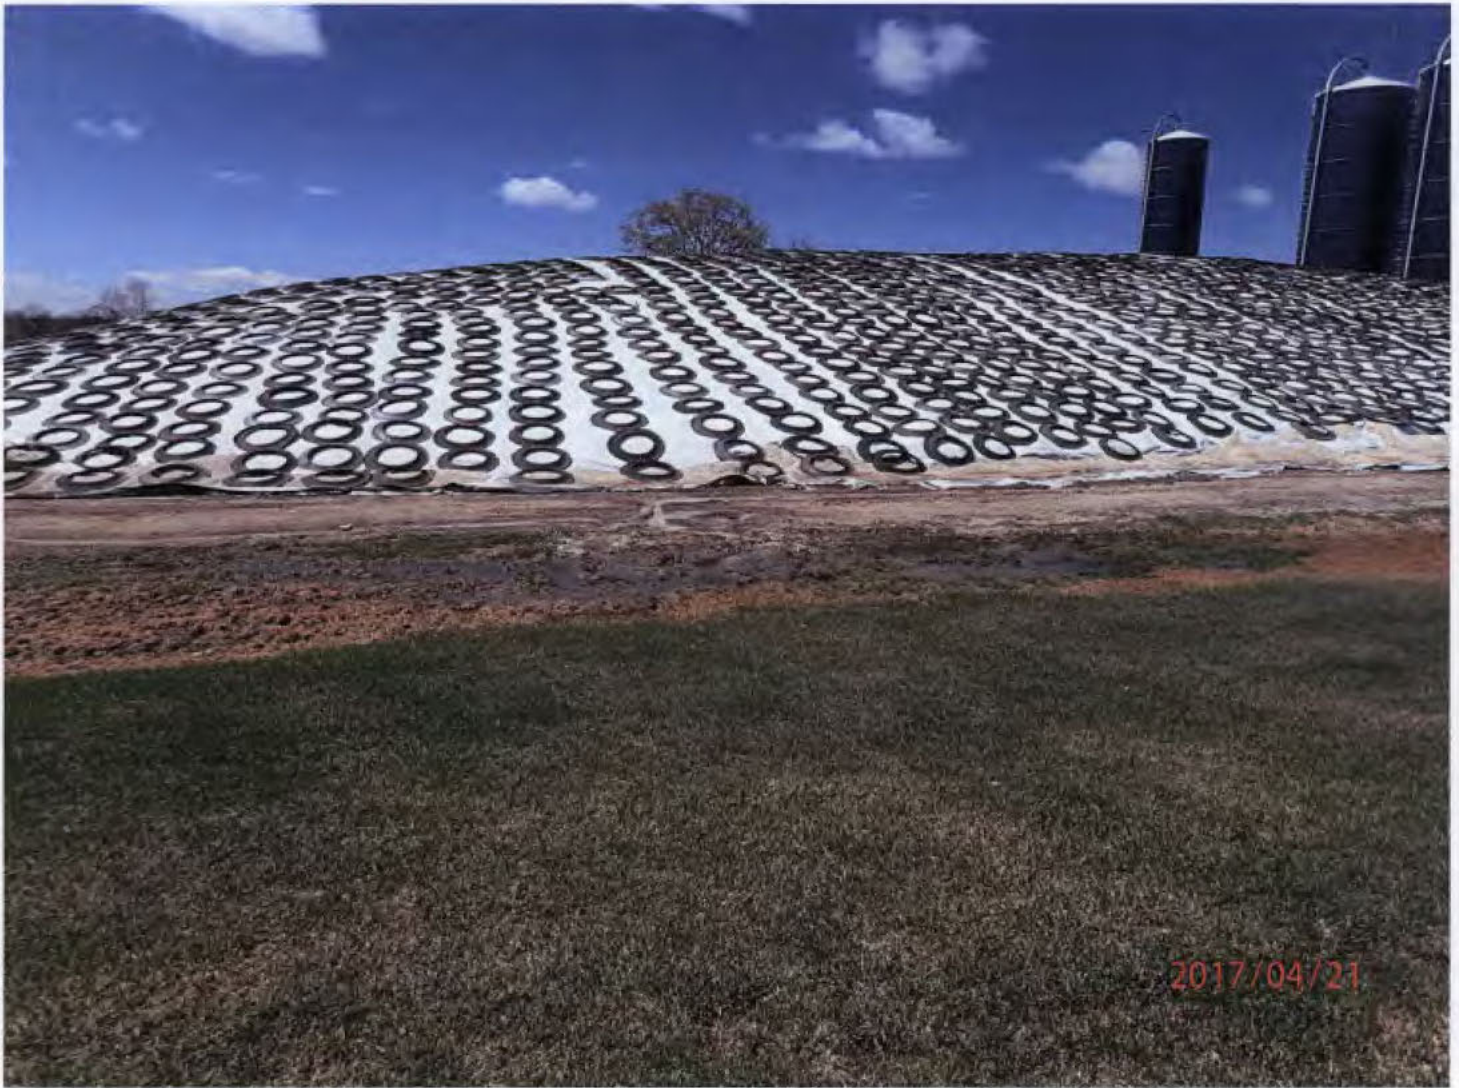
Photo: P4210119

Description: EPA observed feed and surface water (process wastewater) discharging off of the silage pad into the roadside ditch west of Lilac Lane.
